# Manhole Inspection Summary

Manhole # S11Q\_\_009MH

**Location** Address: **523 Wellesley St**

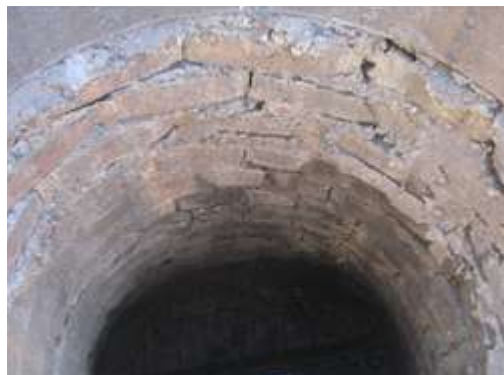
Defect 5

Condition: ☐ Sound ☐ Cracked ☐ Root Intrusion ☒ **Loose Brick** ☐ Deteriorated

Condition: ☐ Sound ☐ Cracked ☐ Root Intrusion ☐ Loose Brick ☒ **Deteriorated**

Loose bricks and mortar in chimney/  
evidence of infiltration in corbel

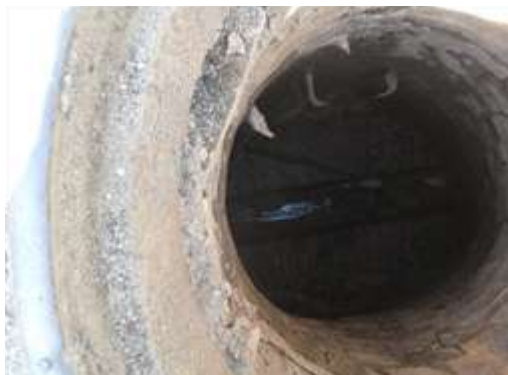
Defect 6

**Frame** Offset: **2** (in.) Condition: ☒ Sound ☐ Cracked ☐ Leaks

Frame offset 2"

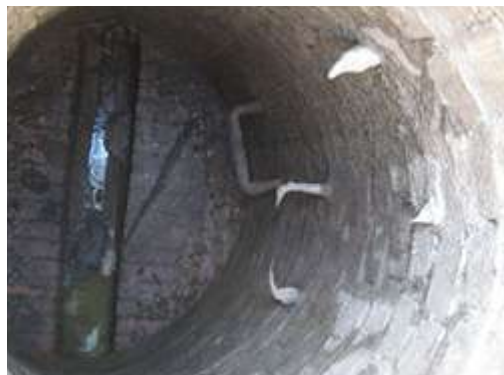
Defect 4

Infiltration: ☐ None ☐ Joint ☐ Cracks ☐ Mortar ☐ Roots ☒ **Wall**

**Steps** Count: **3** Missing: **2** ☒ **Corroded**

Corroded and missing steps/ Barrel  
infiltration

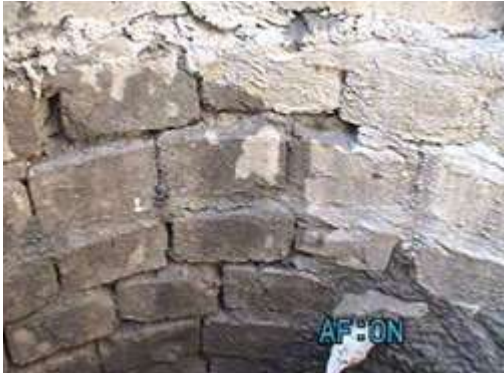
Defect 3

Infiltration: ☐ None ☐ Joint ☐ Cracks ☐ Mortar ☐ Roots ☒ **Wall**

infiltration in corbel and chimney wall pic 2

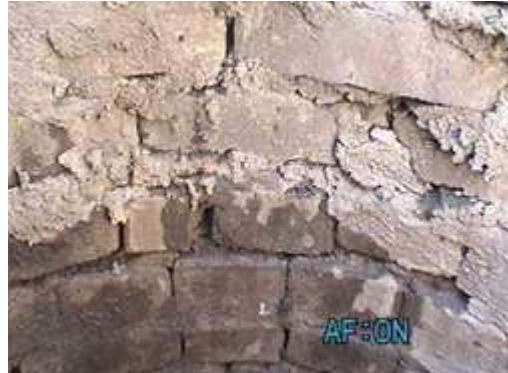
Defect 2

Condition: ☐ Sound ☐ Cracked ☐ Root Intrusion ☐ Loose Brick ☒ **Deteriorated**

Loose bricks and mortar in barrel wall; infiltration in barrel

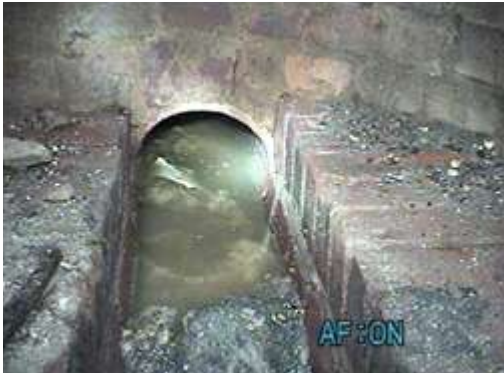
Defect 1

Condition: ☐ Sound ☐ Cracked ☐ Root Intrusion ☐ Deteriorated ☐ Leaks ☒ **Debris**

Debris in channel

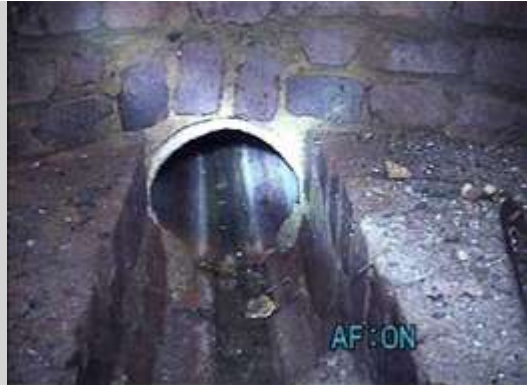
12 O'Clock Outflow

8 in. Circular Gravity Sewer  
Pipe Out @ 12 O'Clock

Pipe Height: **8.4** (in.) Rod and Bar (Angled)  
Pipe Material: **Clay** ☐ Pipe Lined  
Invert Depth: **7.86** (ft.) Flow Characteristics: **Slow**  
Deposits: ☒ None ☐ Mud ☐ Sludge ☐ Debris ☐ Grease  
Silt Depth: **5** (in.) Deposits Extent: **Medium**  
Infiltration: **None** Pipe Seal Cond: **Sound**

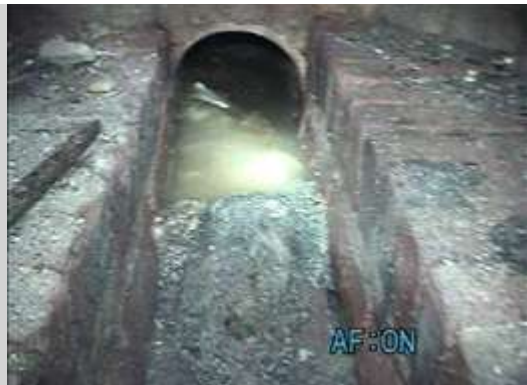
6 O'Clock Inflow

8 in. Circular Gravity Sewer  
Pipe In @ 6 O'Clock

Pipe Height: **8.4** (in.) Rod and Bar (Angled)  
Pipe Material: **Clay** ☐ Pipe Lined  
Invert Depth: **7.96** (ft.) Flow Characteristics: **Slow**  
Deposits: ☒ None ☐ Mud ☐ Sludge ☐ Debris ☐ Grease  
Silt Depth: **5** (in.) Deposits Extent: **Medium**  
Infiltration: **None** Pipe Seal Cond: **Sound**
